BIODETERIORATION OF WOODEN CHURCHES
AND DEVELOPING A STRATEGY FOR
RESTORATION. CASE STUDY:
THE CHURCH OF URȘI

Ioana Gomoiu, Dan Mohanu, Ileana Mohanu*

Keywords: biodeterioration, biodeteriogens, brown rot fungi, white rot fungi, boring insects, mural painting, wooden church, Urși

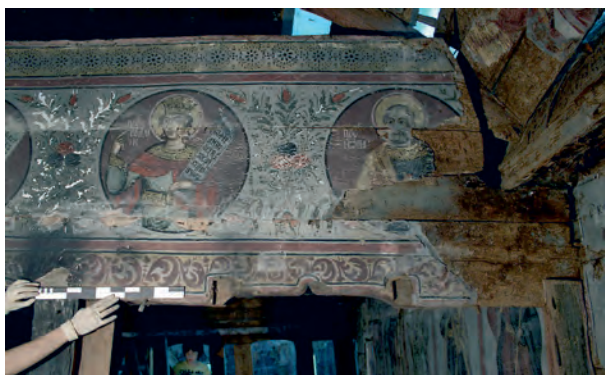
Fig. 1. Beam no. 2 shows the characteristic morphology of the biodeterioration process.

A special situation is presented by the beams with mural painting which make the dividing gable wall between pronaos and naos. Here, in order to restore the structural integrity of the church, one of the beams – tagged no. 2 – had to be removed for treatment, together with its paintings covering both faces. On the surface facing the pronaos, at both ends, around the joining points with the beams in the sidewalls, in the areas where the mural painting had disappeared, a typical morphology for the mycelium and fructification bodies could be identified (Fig. 1). On the surface facing the naos, as well, at both ends, a similar lack of painting (on a smaller area) and the same microbiologically characteristic morphology were revealed. Penetrating damp was a factor of degradation which contributed significantly to the growth and multiplication of the biodeteriogens in these areas. The spread of *Antredia* species *in situ* was favoured by air currents that carried both spores generated by the fructification bodies, and mycelium fragments.

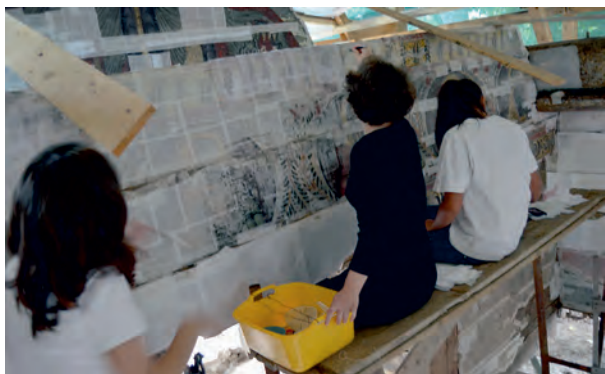
Fig. 2. Securing the pictorial layer before removing beam no. 2.

In order to establish the conservation-restoration protocol, *beam no. 2* was examined and then treated sequentially as follows: biodeterioration identification and location *in situ*, securing pictorial layer (Fig. 2), dismantling (Fig. 3), biocide treatment, packaging and transportation to NUAB. At the studios of the Conservation and Restoration Department of NUAB, *beam no. 2* was examined on both faces and all edges in order to reveal biodeteriogens, size of biodeteriorated areas and changes in the structure of wood.

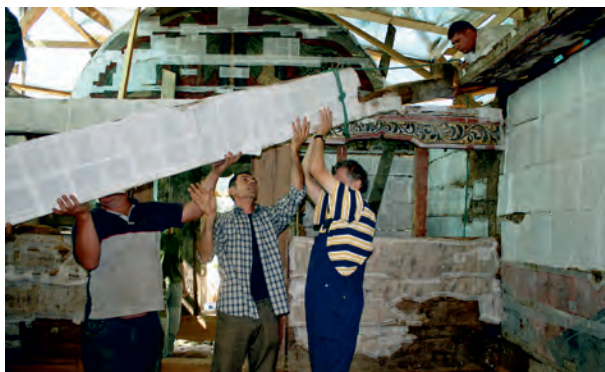
Fig. 3. Dismantling of beam no. 2.

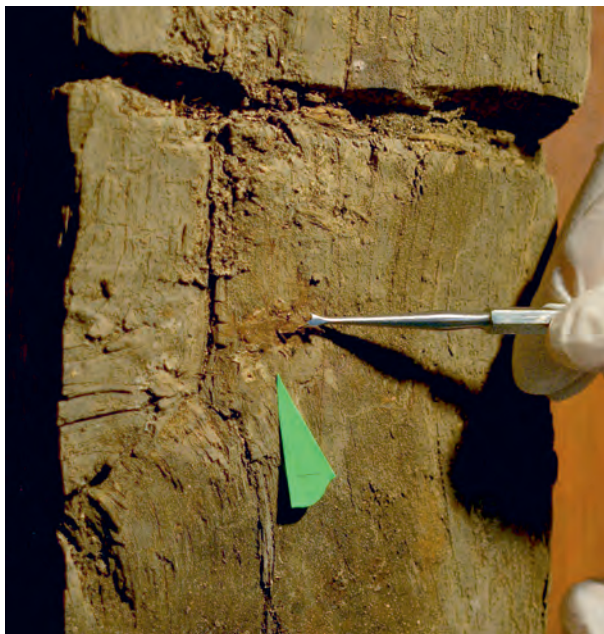
Fig. 4. Wood sample covered by brown thick mycelium.

The wood samples which were apparently hard but covered by thick, crusty and brown mycelium (Fig. 4 and Fig. 5) became friable during harvest activity. The seemingly normal appearance is given by the crusty mycelium which keeps the cellulose fibres in a common package, even though they are fragmented. After removing the crusts of mycelium, it was found that the wood was discoloured as a result of hydrolytic activity of ligninase and cellulases synthesized by the mycelium. On the underside of the sample, the mycelium was white with felty aspect (Fig. 6); it was protected by the crusty part, thus maintaining its viability. Microbiological analyses revealed that the area had been contaminated with *Phellinus* sp.

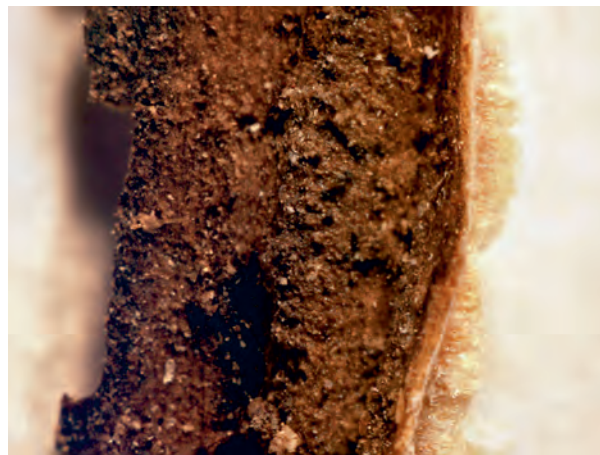
Fig. 5. The top surface of the sample confirms, by optical microscopy, the existence of thick, brown mycelium and deposits (*Phellinus* sp.; magnification $\times 80$).

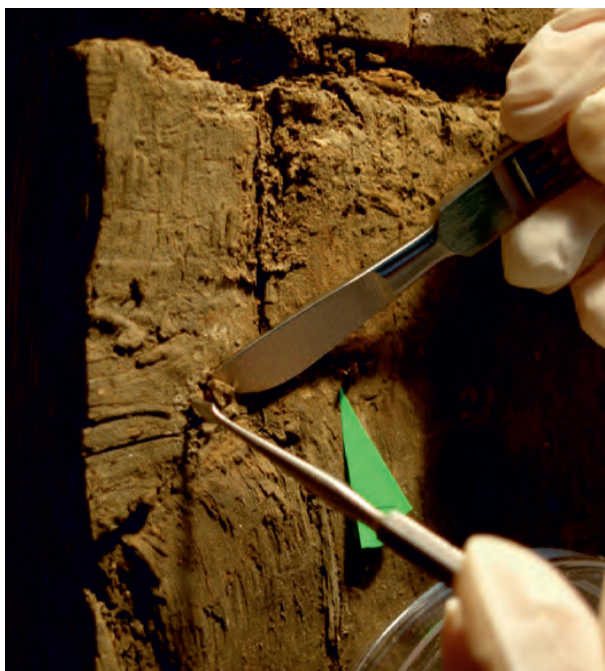
Fig. 7. On sample harvesting for microbiological analysis, it was found that the wood is friable.

Those wood samples apparently hard but fragmented in cuboid forms covered by white mycelium with felty aspect (Fig. 7) became friable after collection, with visible discoloration. Within the wooden beam, layers of mycelium were revealed (Fig. 8), which developed in time depending on alternating environmental conditions, favourable to the species' biology or unfavourable. Contamination with *Antrrodia sinuosa* was found in this area through microbiological analyses.

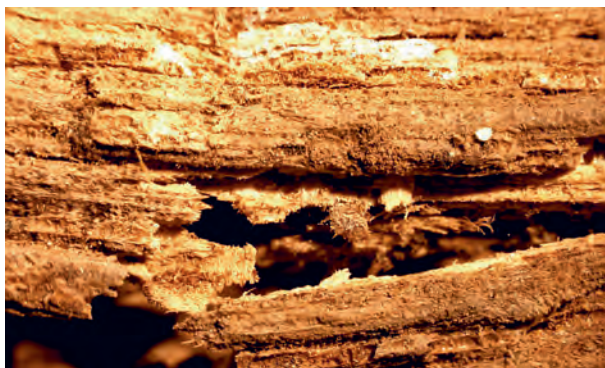
Fig. 8. Deep into the wood consecutive layers of mycelium developed by *Antrrodia sinuosa* ($x = 80$) were revealed.

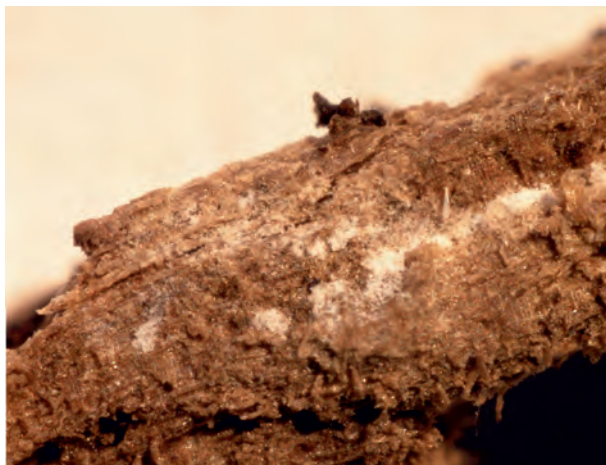
Fig. 10. Brown coloured wood sample colonized on the surface by white and viable mycelium of *Antrodia sinuosa* (x = 40).

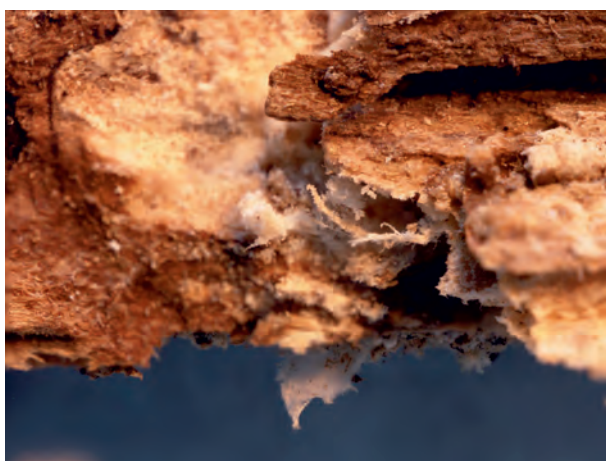
The wood samples showing brown and discoloured areas covered by masses of white mycelium show successive layers of compact mycelium (Fig. 12) grown during periods when the water content was high. By microbiological analyses it was found that the upper part of the sample was contaminated with *Antrrodia sinuosa* and the bottom with *Phellinus* sp.

Fig. 12. Wood sample colonized in-depth by consecutive masses of mycelium (*Phellinus* sp.; x = 80).

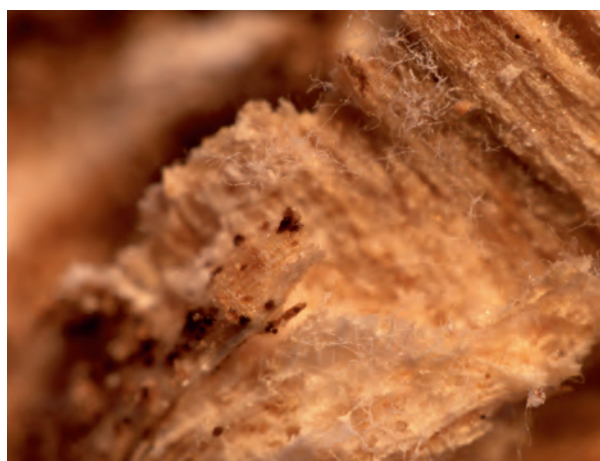
The samples of wood covered with compact and brittle mycelium are contaminated in the depth with *Antrrodia sinuosa*; both aerial and substrate mycelium was revealed (Fig. 13), because of air entering through the many cracks.

Fig. 13. Wood sample colonized by aerial and submerged mycelium (*Antrodia sinuosa*; x = 80).

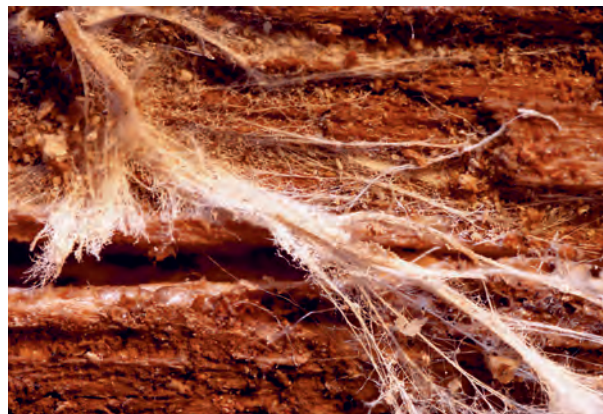
The wood samples with almost normal appearance but covered with strands on the surface (Fig. 17) are completely

Fig. 17. Strands of *Antrodia sinuosa* identified at the surface of the wood sample (x = 80).
