# ONE BRICK - MULTIPLE DISCUSSIONS

Andrei Măgureanu, Alin Anton, Bogdan Ciupercă\*

**Abstract:** In 2013, archaeological excavations continue at the building adjacent to the gate tower of the first precinct of the Princely Court from Târgșoru Vechi (Prahova County). Here, a surprising discovery was made: a brick with one side completely covered with a “drawing” of a church. Dated, probably, in the 16<sup>th</sup> century, this brick raises a number of questions, both from archaeological and architectural point of view.

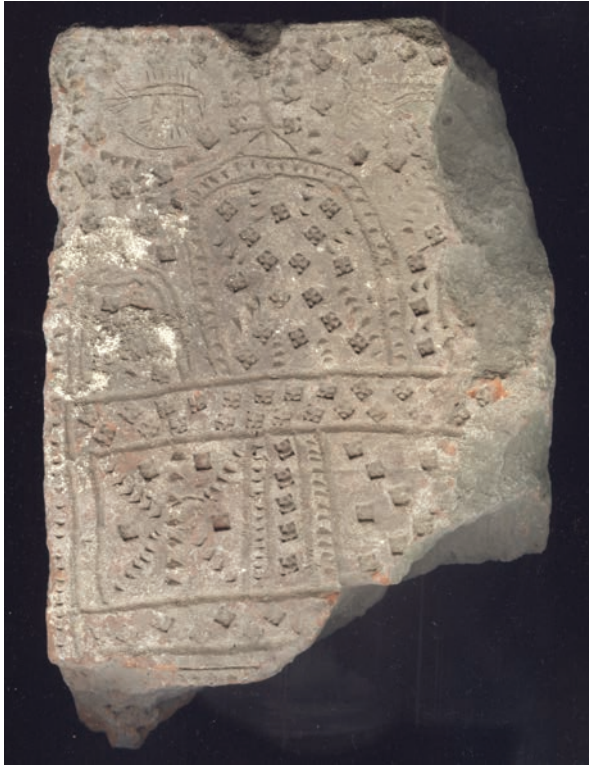
Fig. 1. Photo of the brick.

The artefact is not entirely preserved, presenting a break on its lower part (lower and upper refer to the orientation of the “drawing”) and some more breaks on the sides, so that the original size of the brick is unknown (Figs. 1-2). At present it measures 18.5 cm in length, 14.5 cm in width and 5.55 cm in height. It was made of a hard, compact paste, well fired, brick-coloured. The clay, containing a small quantity of mica, was mixed with calcareous concretions.

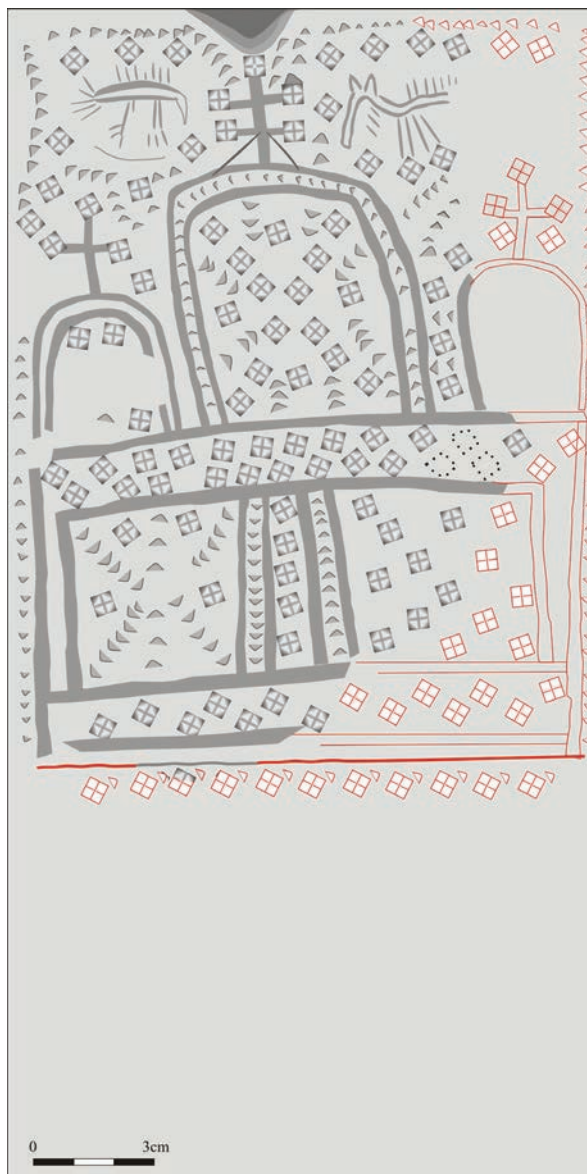
Fig. 3. Reconstruction of entire brick with drawing.

The missing lower part makes for about a third of the maximum length (assumed at about 29 cm, given the fact the norm was that the length had to be double the width). Still, as the piece might have been a special one,

it is possible that the norm had not been respected (Fig. 3).

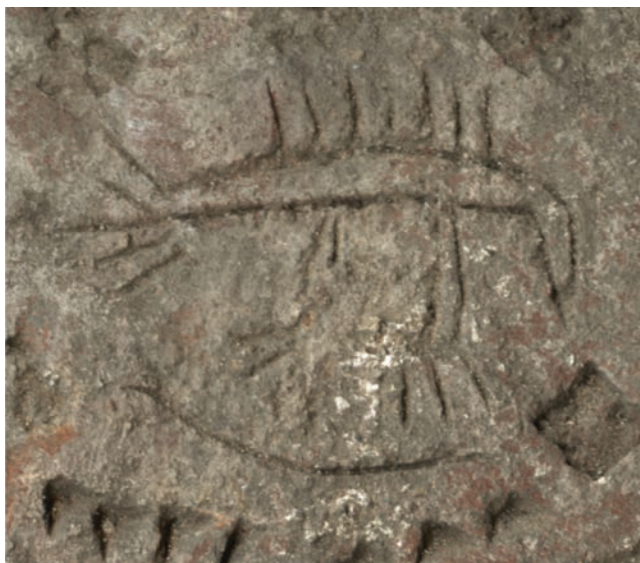
Fig. 4. a. Bird representation; b. Horse/Donkey representation.

Left and right to the cross on the main dome, there are the figures of two animals: a bird and a four legged animal, probably a horse.

For the bird incised lines sketch the body, head, tail, legs and wings. The shape of the beak (long and pointed) and also long well represented claws suggest a bird of prey. Underneath it there is a thin incised line, the same length as the bird. It is thus possible the bird was a vulture or a raven sitting on a tree branch, a motif frequently used in religious painting or on ceramic fireplace tiles.

From the second animal only half was preserved. Also using thin incised lines were realistically made a head with a long muzzle and pointed ears, a long neck on a thin body, legs rather thick when compared to the

body. Accidentally or not, the legs finish in a square – perhaps suggesting hoofs. In this case also we might be dealing with a Christian motif, regardless whether the animal is a horse or a donkey.
