ON THE CONSERVATION OF ARCHAEOLOGICAL HERITAGE: THE CASE OF THE MURAL PAINTINGS IN THE CELLARS OF ȘERBAN VODĂ INN

Dan Mohanu*

Abstract: Following the discovery of mural paintings in Șerban Vodă Han cellars, it seems that we can refer to a new kind of medieval images meant to protect and decorate the place: *cellar icons*.

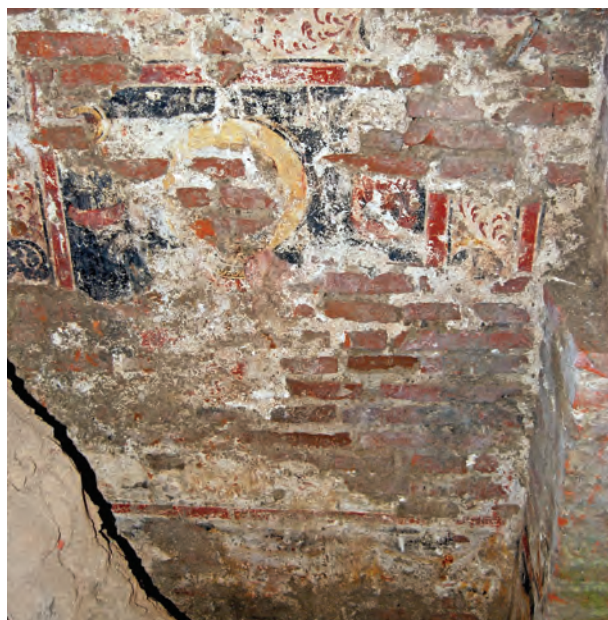
Fig. 1. Icon of St. Nicholas, discovered in the east wall of cellar 4.

The first icon, from east to west, was painted on the eastern wall of cellar 4, in close vicinity to the median pier of the east wall. The image, of about 130 x 150 cm, held the representation of the Holy Hierarch Nicholas (Fig. 1). Traces of the eroded and exfoliated inscription on the right side of the upper section of the icon, on the black background – the “ink” or “background”⁵ (charcoal black with a bit of lime white) allow us to catch a glimpse of the name of the Holy Hierarch. The visage is preserved fragmentarily: most of the ochre aura, and fragments allowing one to read the polilobed beard of the bishop and the shape of his hair. Traces of the greenish *proplasma* (ochre, charcoal black) and the red ochre allow us to reconstruct the drawing of the visage in the technique of Byzantine tradition. The fragments of vestment were part of a red phelonion, with embroidery on an ochre background around the neck, and a pink omophorion, in lime shades. On the black background, on each side of the Holy Hierarch, over the shoulders, on the red (red ochre) clouds, at a smaller scale, are depicted, following intensely used iconographic patterns, Mother of God to the left, and Jesus Christ, to his right.⁶ The icon is surrounded by an ornament outlined by red stripes (red ochre, perhaps cinnabar) following the good tradition of 17th-18th centuries art: vegetal stalks in red ochre and charcoal black alternate on the white lime background (Fig. 2a-b). At the hem of the icon, fragments can be read of a drapery executed alertly, whose pattern continues on the northern face of the pier (Fig. 3).

Painted on the traditional lime-rich support,⁷ made of a single layer with the role of *intonaco*, of variable thickness (0.8 - 3 cm), reinforced with straw and hemp fibre, the icon bears within its fragments certain signs specific to a *fresco* mural painting: traces of the trowel during the scouring process or the incisions of the drawing in the moist ground coat.

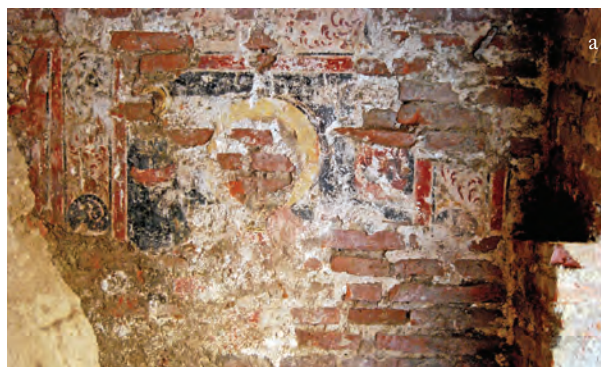
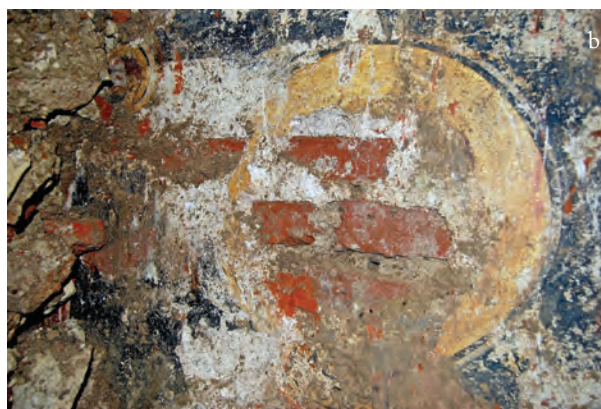
Fig. 2a-b. Overall view and detail of the visage of St. Nicholas, preserved fragmentarily on the east wall of cellar 4.

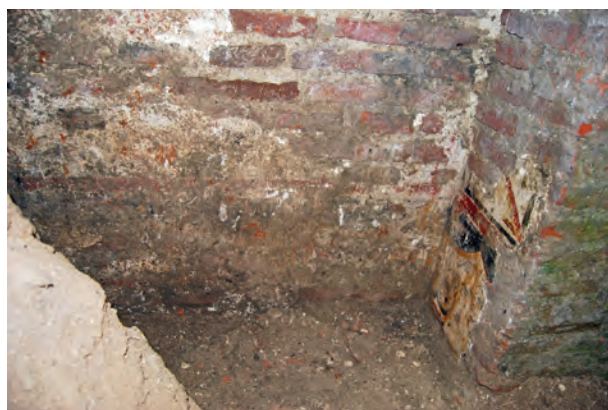
Fig. 3. Detail image with the representation of the draping at the hem of the icon of St. Nicholas painted in cellar 4.

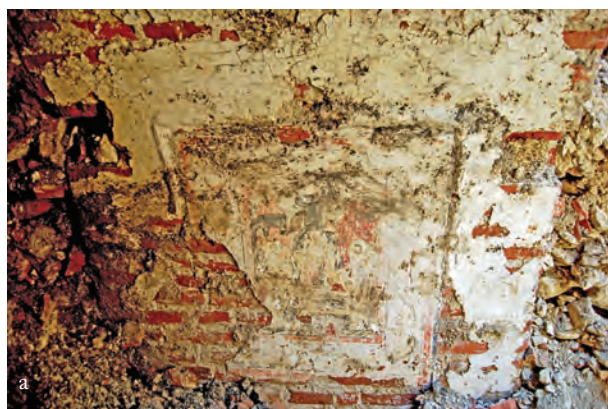
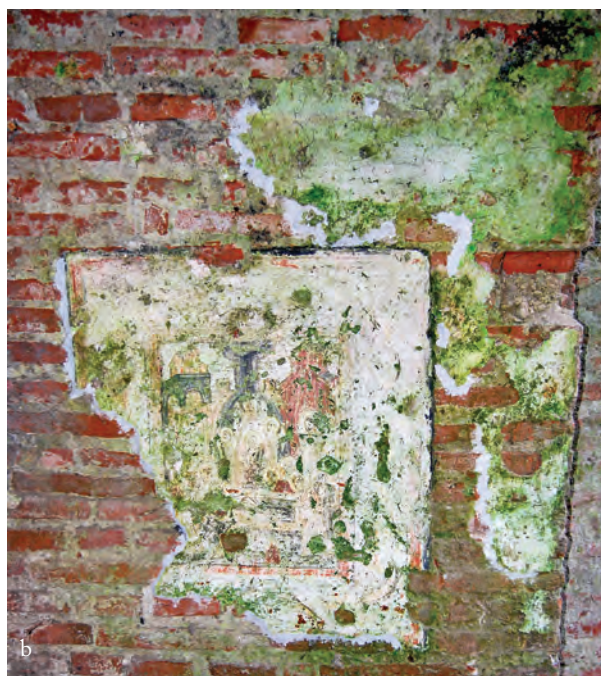
Fig. 4a-b. Images of the icon of the *Dormition of the Mother of God*, taken immediately after the disinterment from the mix of earth and rubble (a) and after the clearing of the biofilm developed as a result of biological attack (b).

The second fresco icon, on the East pillar of the arch at the passage from cellars 2 to 5, was about 120 x 110 cm (Fig. 4a-b). Preserved as fragments, as well, it had suffered also extensive losses of the painting layer. Numerous lacunae of the support, from the extended ones which had destroyed the outer area of the painting, to the small ones scattered about on the icon itself and the decorative frame around it, were causing an irreversible discontinuity of the image. The precarious state of the painting support, with lacunae and lack of adhesion to the brick masonry, the discoloration of the entire image by flaking and erosion of the paint layer disclosed action of degradation factors, starting with the implacable human action which had destroyed and buried, finally and aggressively the ruins of the old medieval han, up to the converging action of humidity and biodeterogene factors (Fig. 5a-b). Close in size to a wooden icon, the image in fresco was dedicated to

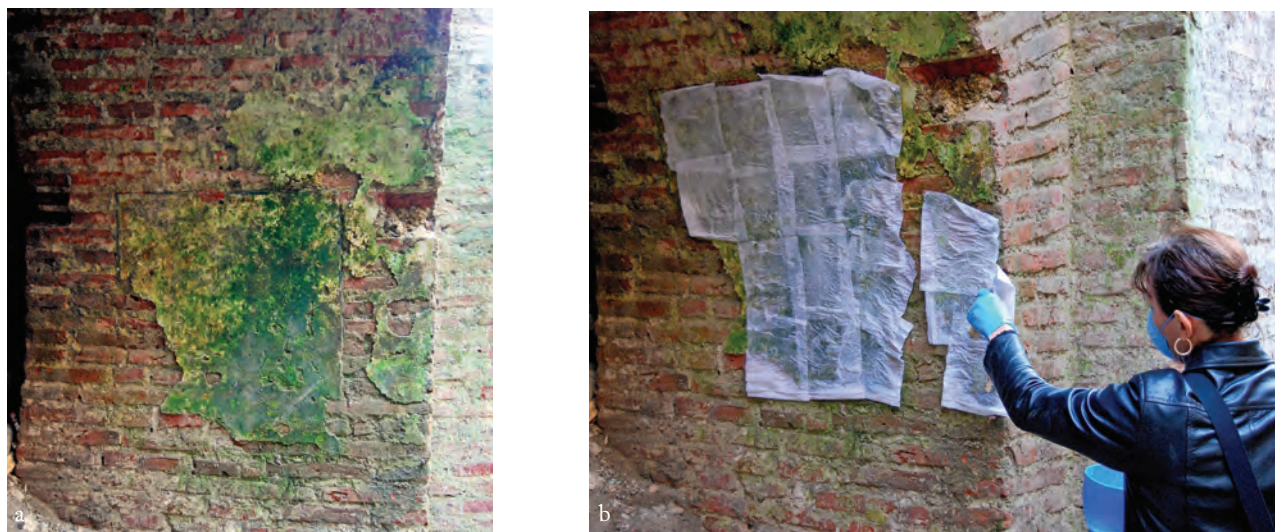
Fig. 5a-b. The icon of the *Dormition of the Mother of God*, after the biological attack (a) and during the biocide operations (b).

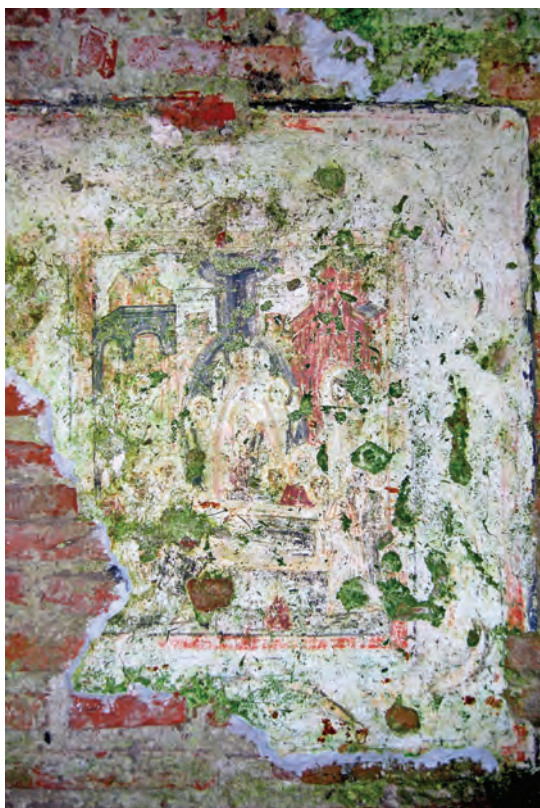
Fig. 6. The icon of the *Dormition of the Mother of God* painted on the east pillar of the arch at the passage from cellars 2 to 5.

the representation the *Dormition of the Mother of God*. The selected iconographic alternative included the scene of the *Dormition* together with the *Ascent* of Mary's soul into the Kingdom of God (Fig. 6). The icon was surrounded by a generous ornament where the painting and stucco flat relief merged in a fine expression, established in the mural decoration of the end of the 17th century and the beginning of the 18th. Of the precious icon frame only a few hints had survived: the red stripes, indefinite traces of the ornament, apparently with stalks, along the delicate stucco mould which, together, separated the icon from the mural surface.

of a talented fresco- and icon painter, the representation of the *Dormition of the Mother of God* had been completed on the fresh lime ground, strengthened with hemp fibre, in a relatively homogenous layer, more consistent (0,8 - 1 cm thickness) inside the stucco frame. A network of contraction splits mostly present in the exterior rendering of the icon, indicated the high humidity of the support-masonry affected by infiltrations and ultimately buried in the mix of earth and debris.

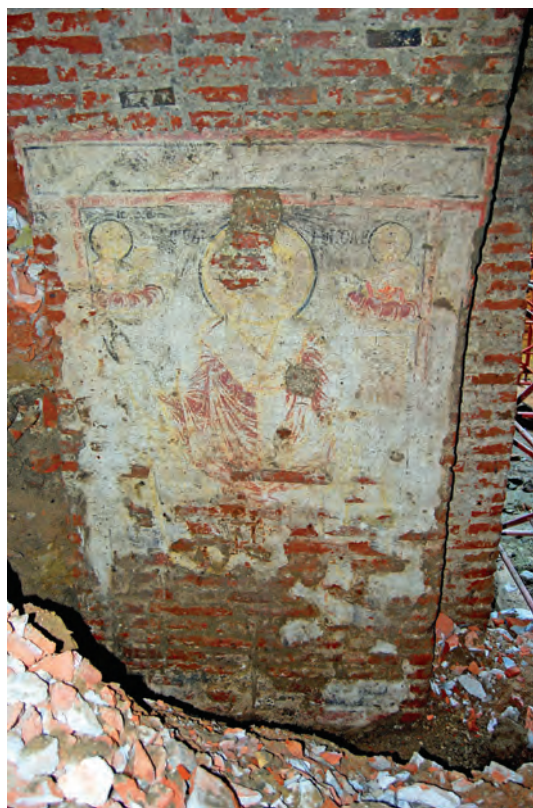
Fig. 7. The second icon of St. Nicholas, painted in fresco on the pillar at the east extremity of the arch at the passage from cellars 3 to 6.

The third icon, on the pillar to the East of the arch connecting cellar 3 to cellar 6 was assigned once again to the representation of the Holy Great Hierarch Nicholas (Fig. 7). Larger in size than the other icons – 135 x 232 cm – the image was framed by the well-known Byzantine type of ornament, zigzag-like structure inside which palmettes alternate, painted with charcoal black and red ochre. Two red stripes outlined the ornament. Despite the fact that most of the ground plaster had survived the aggression of degradation factors, a strong process of flaking and abrasion of the colour layer had turned the icon into an image similar to a negative or the back side of a mural painting extracted by pulling up the paint layer (*strappo*).

The iconographic version used in the second representation of Saint Nicholas was similar to the one used for the first icon, preserved fragmentarily onto the east wall of the six cellars ensemble. The Holy Hierarch Nicholas appeared vested in a red oxide phelonion with an omophorion, whose tonality and ornaments had completely vanished. Next to his visage, of which mere traces of the preparatory drawing with yellow ochre were still perceptible (Fig. 8), the scene included Jesus Christ to the left (Fig. 9) and the Mother of God to the right, standing on clouds rendered on red oxide base. On the black background, one could read quite easily the traces of the saint's inscription, initially written in lime white. At the base of the icon, fragments of a curtain suggested the way the decoration of the pillar ended, in the spirit of religious mural painting. The colour range,

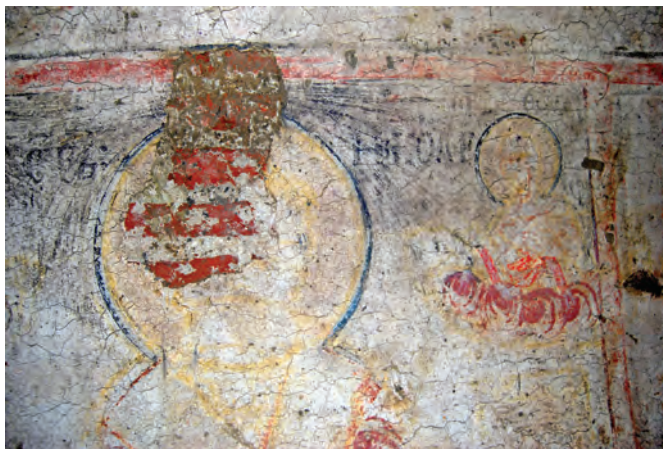
Fig. 8. Detail with the visage of the second representation of St. Nicholas. The preparation drawing is visible, made with yellow ochre.

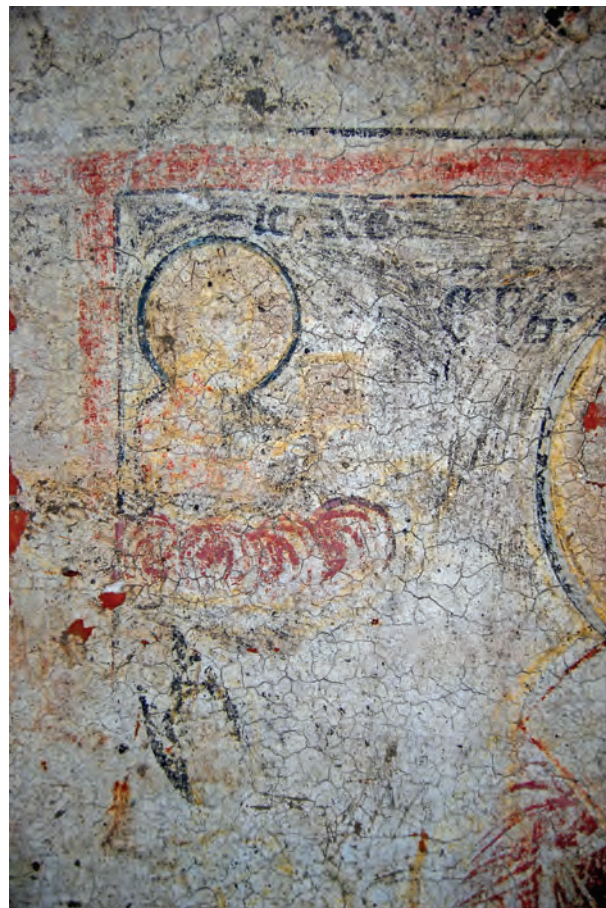
Fig. 9. Similar to the iconographic version in the first icon of St. Nicholas, the Great Hierarch is flanked in the area of the visage by Jesus (in the photograph) and The Mother of God.

restrained, kept similar marks to the first icon of Saint Nicholas: the charcoal black background, the yellow ochre, the red oxide, the cinnabar red (traces still visible on the vestment of the Mother of God), and lime white. The layout of the phelonion folds, of the clouds holding Jesus and Mother of God, the style of writing, lead to the dating of the icon in the second half of the 18th century.

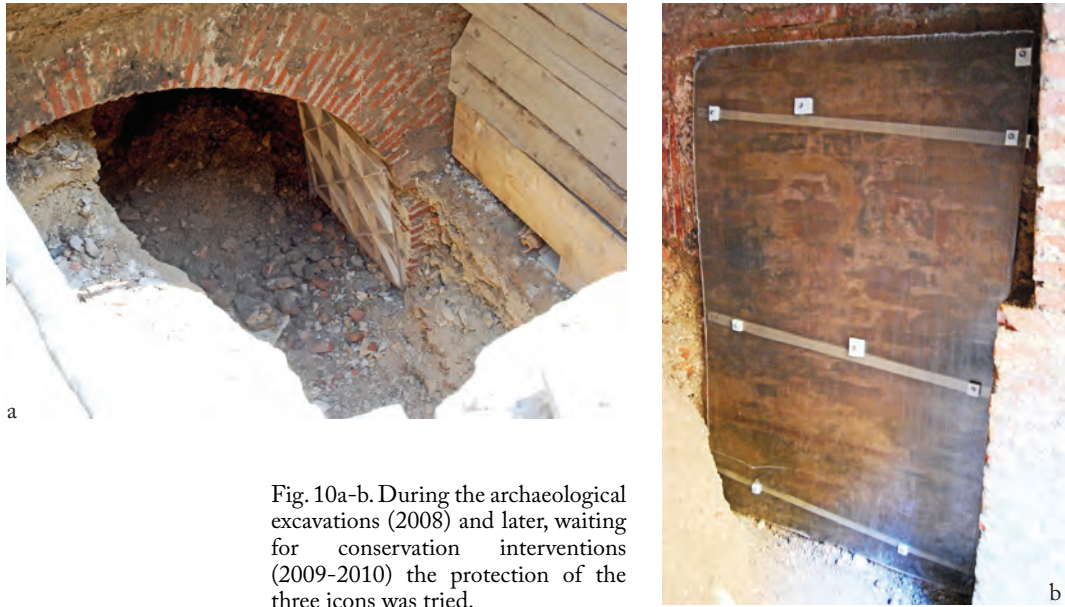
Fig. 10a-b. During the archaeological excavations (2008) and later, waiting for conservation interventions (2009-2010) the protection of the three icons was tried.

Located in the area within the ruins of Șerban Vodă Han, proposed for conservation,⁹ the three cellar icons were to undergo certain procedures for the protection and conservation *in situ*. In July 2008, the discovery of the first two mural icons – Saint Nicholas on the east wall and the Dormition of the Mother of God in the archaeological excavations on the southern side of the National Bank – encouraged us to propose¹⁰ an emergency consolidation intervention followed by a temporary shelter to stand until the end of the archaeological investigation and the inclusion of the area in a conservation and enhancement process (Fig.10a-b). There was even hope for a small museum space dedicated to the old Princely Han. The protection of the archaeological site had to withstand at least two redoubtable degradation factors: man and his destructive potential through vandalism or neglect and humidity with all its consequences, from the migration and recrystallization of soluble salts, to a dislocation produced by the frost-defrost phenomenon and the biological attack. Although

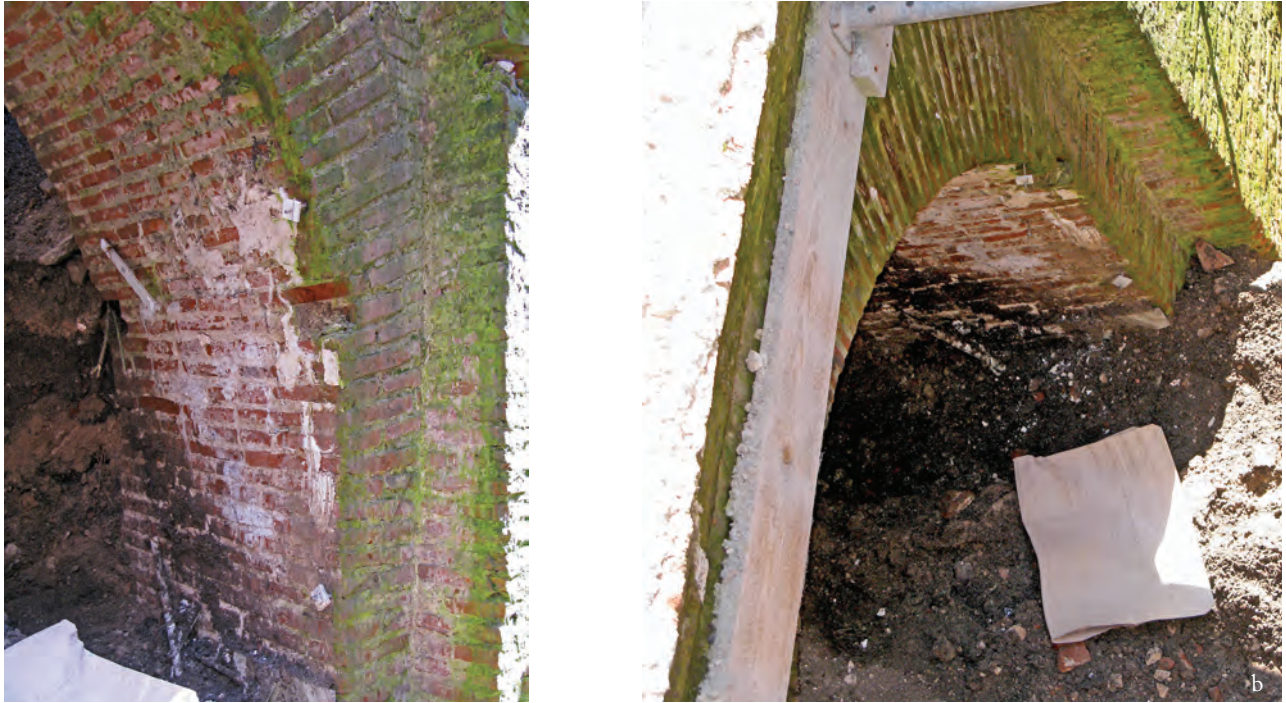
Fig. 11a-b. In absence of an appropriate protection of the ensemble of ruins led to the infiltration of rain water, installing and extending of biological attack, vandalizing of the area with the three mural paintings and, lastly, the disappearance of the icon of the Dormition of the Mother of God and of the second representation of St. Nicholas.

the vicinity of the National Bank seemed a further reassurance for the protection and enhancement of the site, events pointed out that the most illustrious of vicinities is not a guarantee of an unaltered survival of the heritage. Left under a precarious protection, fully exposed to degradation factors, the ruins of princely cellars underwent a massive biological attack, especially in the area exposed to light and humidity. The most precious, by the clean technique, the richness and finesse of details, the icon of the Dormition of the Mother of God turned unrecognizable under the attack of the “green illness”. Excessive humidity in autumn, winter and spring made impossible any proposal of conservation, as well as any attempt to extract it in acceptable technical conditions. Those conditions, swiftly leading to the conclusion of suppressing any claim of *in situ* conservation of the mural paintings, was complemented, as a supreme reason, the collapse of the mass of debris waiting to be evacuated from cellars 4-6 over the fragments of mural painting. Pulled from the wall and turned into rubble or irrecoverable fragments, the precious icon of the *Dormition of the Mother of God* was finally destroyed (in 2009) (Fig. 11a-b). The same happened to the second icon of Saint Nicholas. The decision to extract what was left of the first icon of Saint Nicholas was taken in completely unfavourable conditions to an extraction. The entire succession of events concluded with a rapid extraction, in ultimative conditions, unprofessional and with improvised materials.

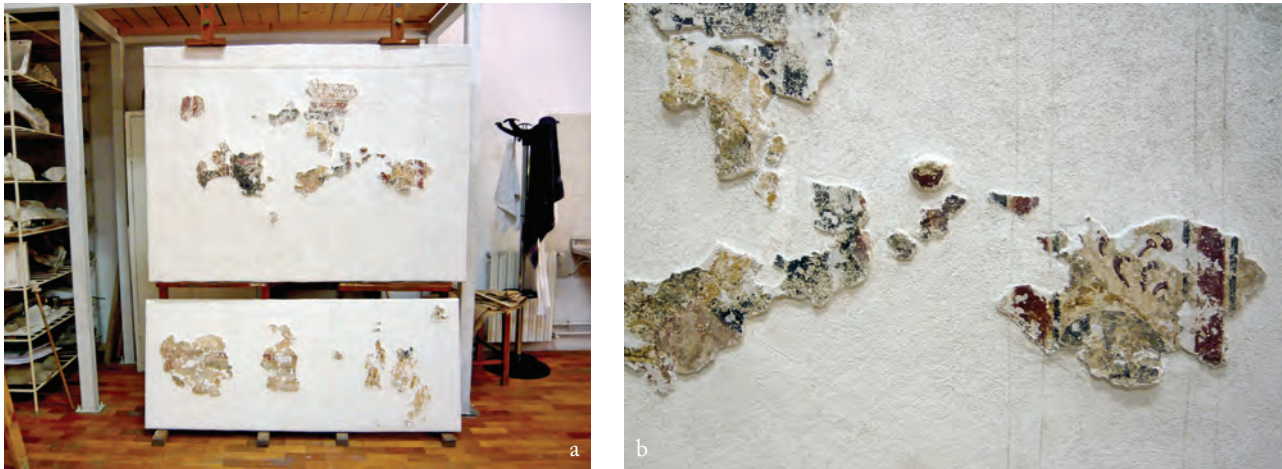
Fig. 12a-b. The transposition on a new support of fragments which have survived an unprofessional extraction, in precarious conditions, sought to achieve as much as possible a reconstruction of the icon of St. Nicholas from cellar 4, as it had been preserved *in situ*.

At the arrival in the mural painting workshop (currently study programme) of the Conservation-Restoration Department of the National University of Arts, the fragments of the first icon of Saint Nicholas made the subject of a recovery intervention close to the impossible.¹¹ Extracted by fragments, with no reassemblage scheme, the icon of Saint Nicholas would have been condemned to the impossibility of its recomposition outside a photographic documentation previous to the extraction completed by the team of restorers of the Conservation-Restoration Department, based on the occasion of the investigation *in situ* and the intervention of temporary protection of the mural paintings. Extracted by the application of a coloured cloth, inappropriate for this operation, the fragments had been insufficiently rigidized by means of an improvised framework of fragile fir battens. Further mention should be made about the microclimate conditions, unsuitable to extraction, with excessive humidity, a neglected architectural space where operations took place, mostly invaded by debris

and, most of all, a biological attack extended on the masonry surface. Out of such a conservative environment, what would reach the restoration workshop were fragments of mural painting with dislocations of their support, covered by impurities, and with morphologies typical to fungal attack. Fragments, therefore, not accessible prior to their biocide treatment. Once this action completed, it was possible to clean the back of the fragments, to consolidate them by injecting the cracks and by anchoring separated fragments, removing, as much as possible, the excess of mortar from masonry joints, and the application of a first layer of gauze, part of the backing stratigraphy. Thus consolidated and rigidized, the fragments could be freed of the improvised facing of coloured cloth and wooden battens. Out at light, surviving fragments were reassembled based on the photographic records, in the attempt to reconstruct the icon of Saint Nicholas, to the greatest extent possible, as it was *in situ*. To benefit the reading of fragments, they were planted into a coat of *arriccio*, based on lime mortar, where the outlines for the ornamental frame of the icon and the Holy Hierarch's halo were incised. The transposition of recovered fragments was completed in reversible conditions on a multilayer support (Fig. 12a-b), made of textile layers in contact with the mural painting fragments and their *arriccio*, followed by an easily reversible polystyrene layer and the rigid polycarbonate structure.

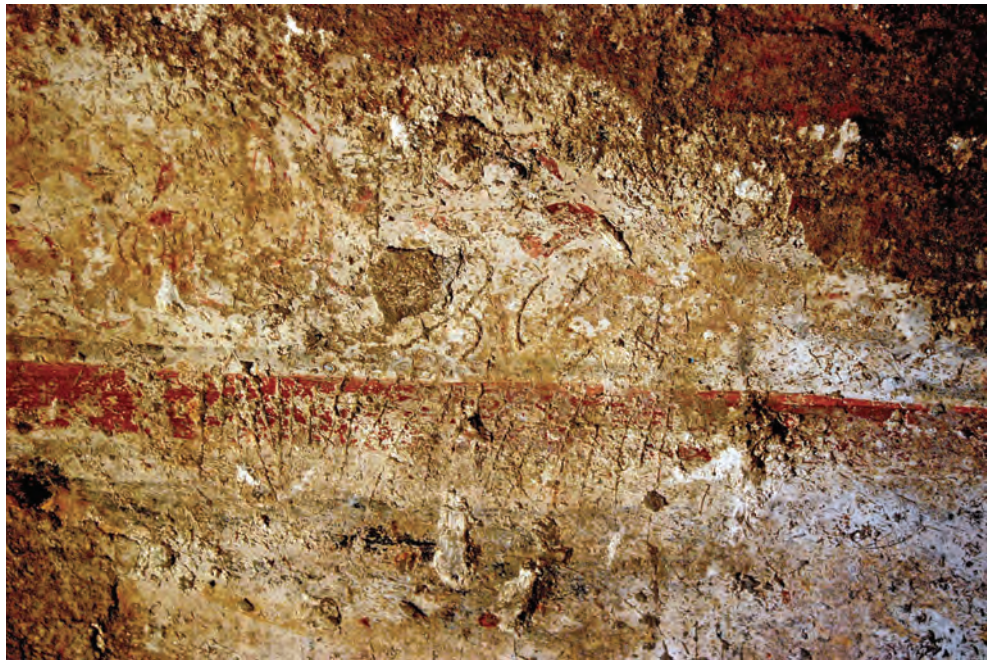
Fig. 13. The graffito at the hem of the first icon of St. Nicholas (cellar 4), reading the year 7264 (1756) or 7260 (1752).

Were there any graffiti in the ruins of Șerban Vodă Han, after all? The question should have concerned, first of all, the three icons whose lime ground easily allows the incision of signs or inscriptions. The ground of the mural paintings is often used in the space of our churches to cumulate, from simple signs to explicit inscriptions, genuine abbreviated chronicles of a place. In our case, we would have lost any kind of information about the existence of graffiti unless the careful examination of the photographic documentation, in order to reassemble the extracted fragments of Saint Nicholas icon had allowed the discovery of a graffito recording the year 7264 (1754).¹² Other small illegible graffiti are associated with this date (Fig. 13).

¹² The confirmation of the reading comes from Mrs Ruxandra Lambru whom I thank now too. The comment she made available also includes the option of year 7260 (1752), number 4 could have been an incomplete attempt to date the month and day.
