# CORBII DE PIATRĂ. CONCLUSIONS OF A RESEARCH

Dan Mohanu, Ioana Gomoiu, Ileana Mohanu, Marin Șeclăman

Excerpt from ARA Reports 3, 2012.

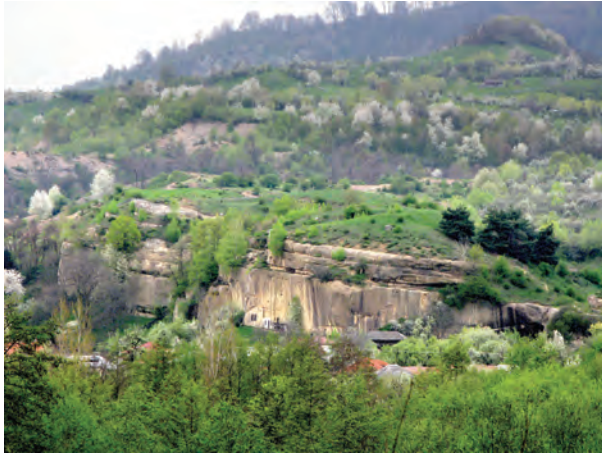
Fig. 1. The historic and natural site Corbii de Piatră. Overall view of the rock where the carved church is.

The initial aim of the research undertaken between 2008-2010 at the rock-hewn church of Corbii de Piatră (Fig. 1) was to provide the scientific foundation required for an adequate approach of the conservation of the medieval site, and particularly of the valuable mural painting ensemble. These mural paintings – with a problem range unprecedented in scope and complexity, especially concerning the biodegradation process – were the major objective leading to the development of the research project.<sup>1</sup>

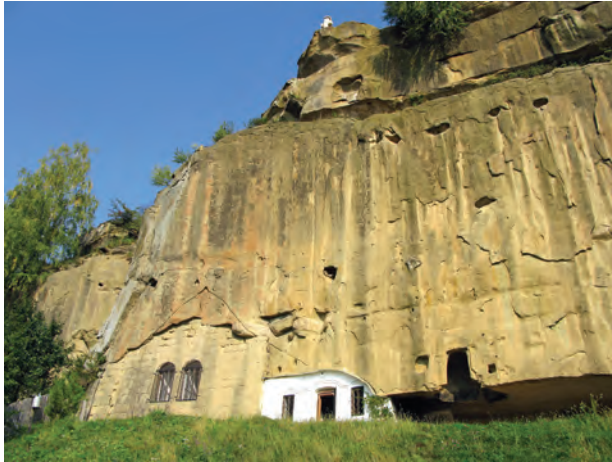
Fig. 2. The rock face where the carved church is comprises the west wall of the naos, reconstructed after the collapse of the initial wall in the 19<sup>th</sup> Cent., the entrance to the porch on the south side of the church and the elongated recess which holds the refectory.

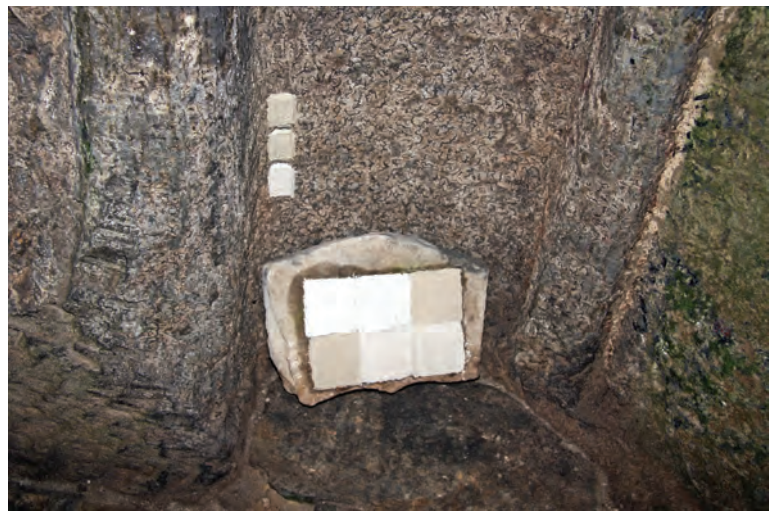
Fig. 5. Samples of different compositions of mortars destined to the consolidation intervention at the painting support have been tested by CEPROCIM S.A. Not only was the compatibility with original materials examined, but the behaviour of new mortars in severe microclimate conditions, too.

consolidation materials<sup>14</sup> (Fig. 5), compatible with the rocks part of the site we deal with, whose application methodology is non-destructive and whose introduction will be made on a minimum of material, as much as possible. At the same time, the emergency intervention includes an attempt to reduce the sources of humidity: infiltration, capillarity, or condensation.

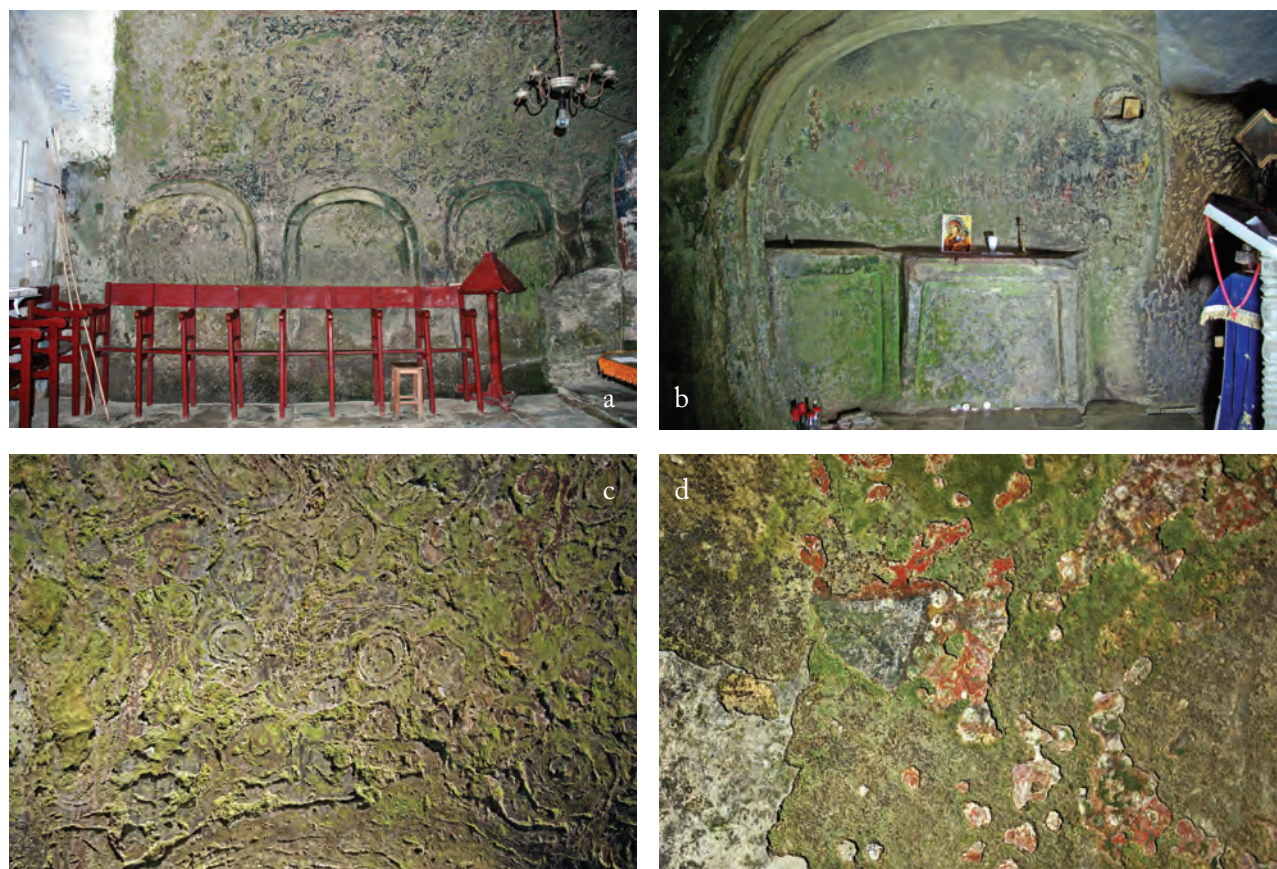
Fig. 6a-d. One of the major problems characteristic to the state of preservation of the rock-hewn church is the ample and complex biodeterioration process.

In what concerns the major issue of biodeterioration<sup>16</sup> (Fig. 6a-d), an emergency intervention comes up with a series of operations aimed to stop and prevent the extension of the degradation process:

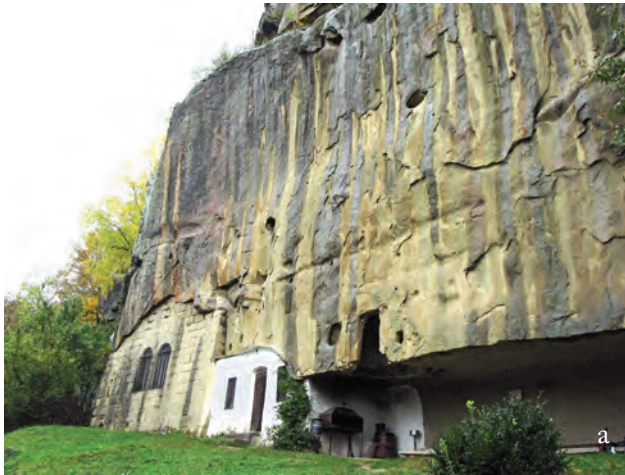
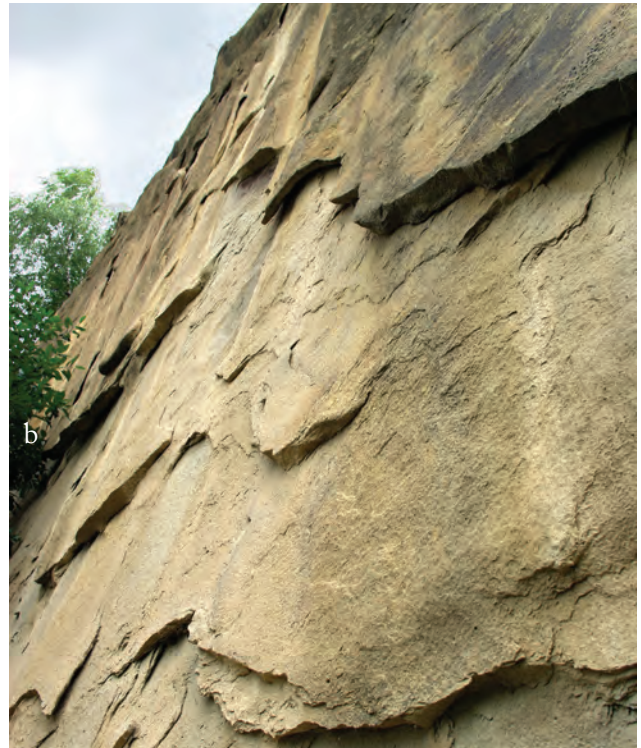
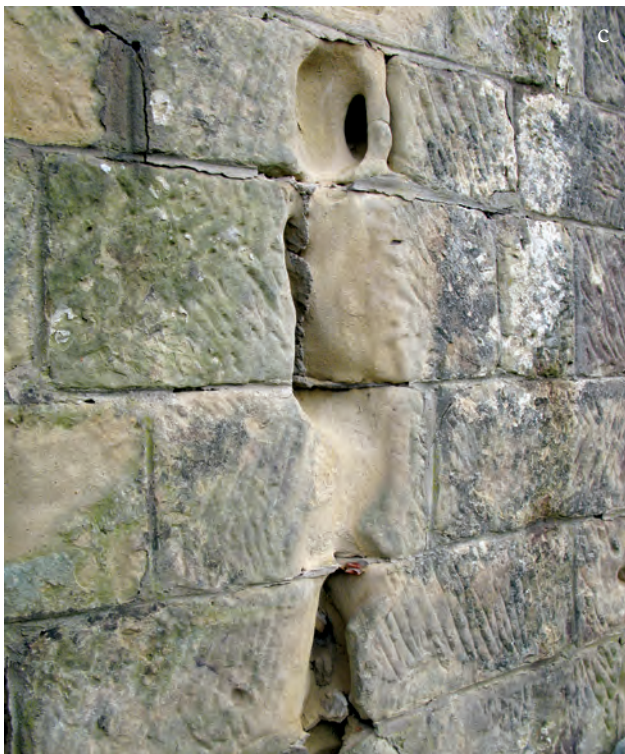
Fig. 7a-c. Subject to infiltration, a microclimate with high variations of temperature and humidity and freeze-thaw phenomena, the fragile sandstone cliff which contains the church is in a process of regressive evolution which endangers the existence of the monument.

The abrupt mountain side outside the church was and will continue to be under a regressive evolution<sup>19</sup> (Fig. 7a-c), which will certainly affect the stability of the site in the future. To assess the moment when the evolution of the mountain side turns critical for the church yard, it is also necessary to elaborate an *in situ* programme of observations, applying certain *markers* in the field and monitoring them over a long time.

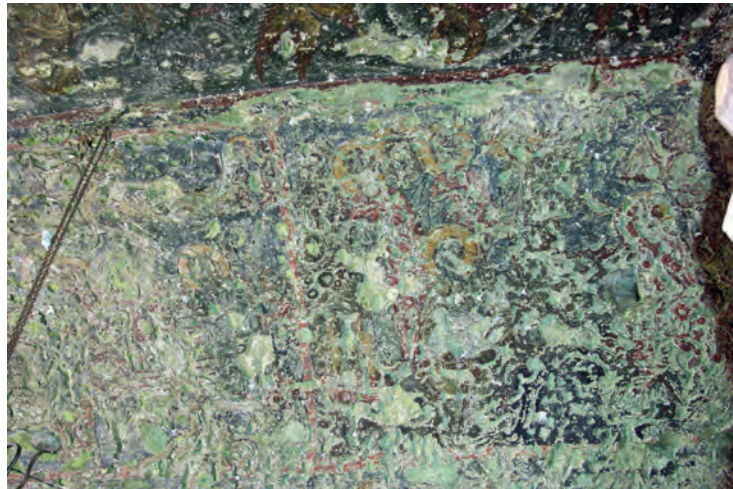
Fig. 8. Generally considered illegible because of the biological attack and the lacunae which spread over the entire painting surface, the north wall of the naos offers nevertheless a possibility of an iconographical decryption in some periods of excessive humidification of the walls. This is how scenes such as the *Harrowing of Hell*, in the photograph, could be identified.

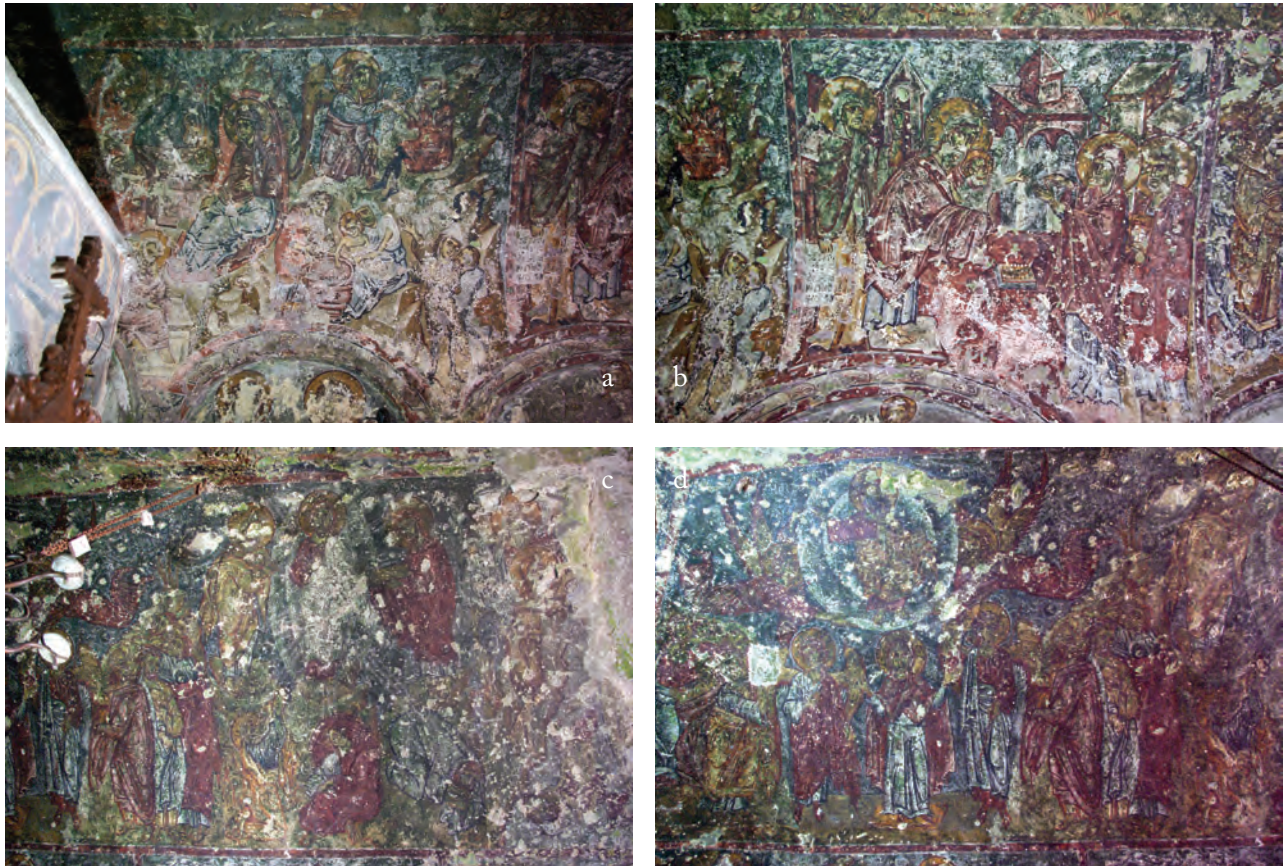
Fig. 9a-d. The most extensive iconographical reading can be done on the south side of the naos vault. Among the scenes which allow also a thorough stylistic analysis is the *Nativity of the Lord* (a), *Întâmpinare Domnului* (b), the *Transfiguration* (c), the *Ascension of the Lord* (d).

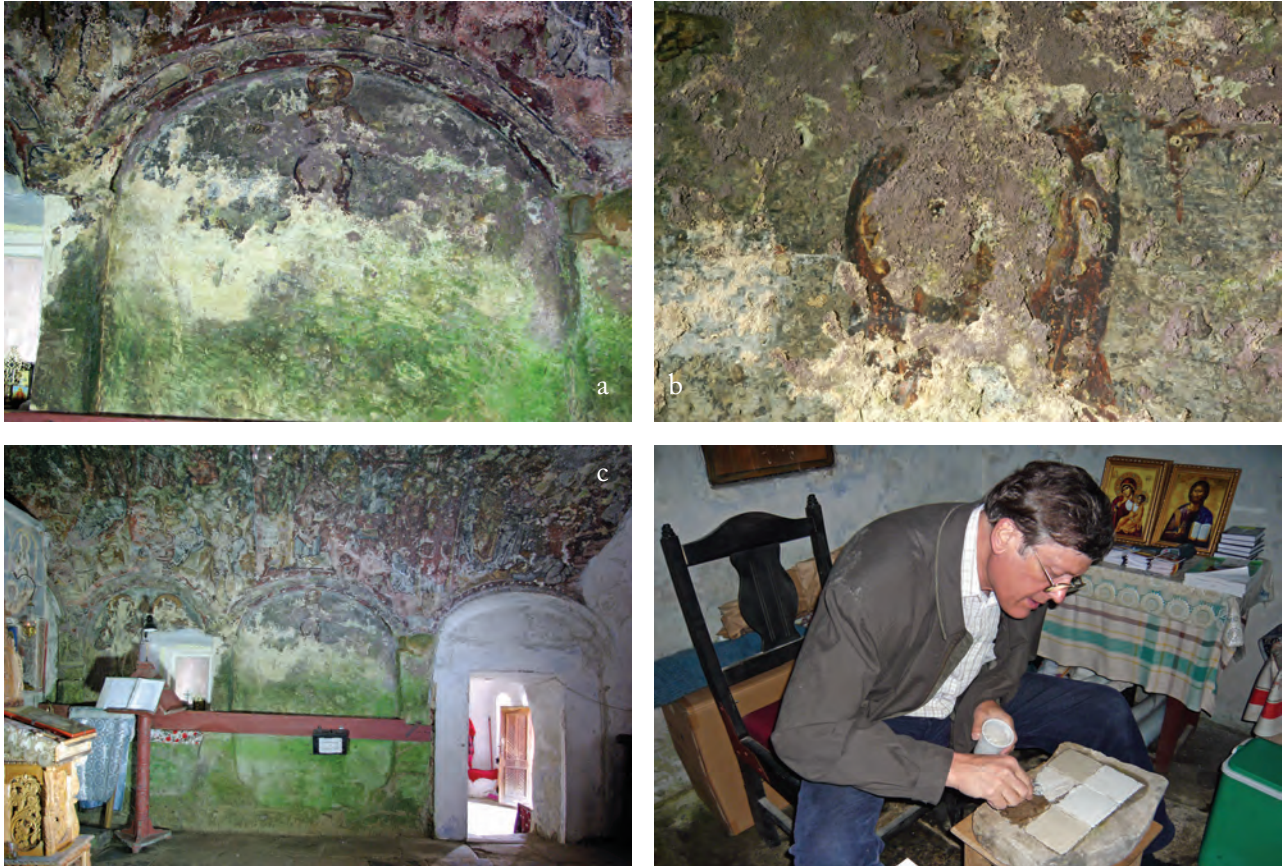
Fig. 10a-c. The central recess of south wall holds the fragments of a votive picture. The figure in the scene axis (b), with frontalized visage, is larger than the other two characters which flank it.

wall, of the votive picture. Even if the identification of the three characters blessed by Jesus Emanuel remains a hypothesis,<sup>21</sup> their representation, with the image of the character along the axis of the niche ampler than the others, and placed in front, is a certainty (Fig. 10).

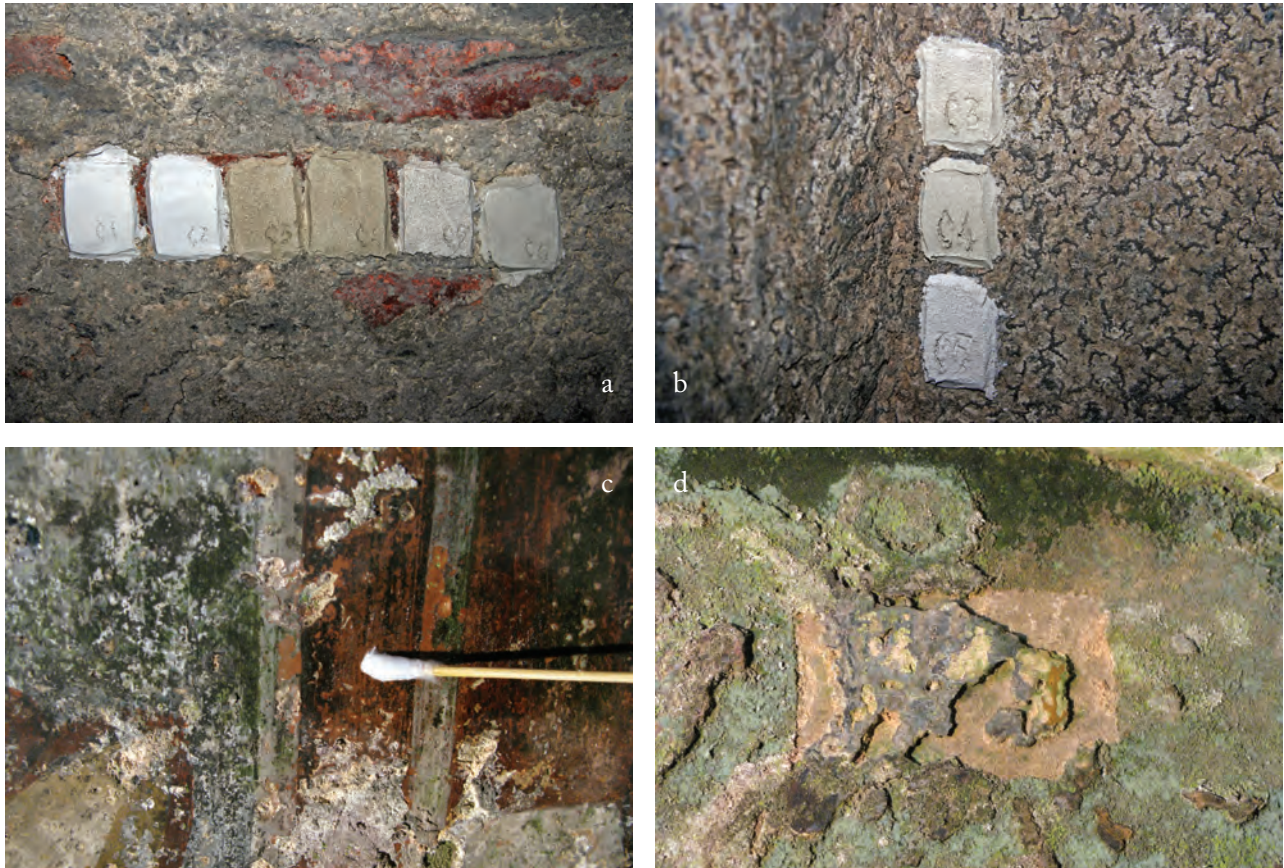
Fig. 12. The tests carried out *in situ* had a conservative character, based on the principle of *minimal intervention*: application of compatible lime mortars, with strictly consolidation role (a-b), cleaning of impurities deposits (c), cleaning and treating against biodeteriogenes (d).

The tests completed *in situ* (Fig. 12a-d) were therefore limited to operations of strict conservation, imposed by the current major degradation and eliminating any attempt to treat the faults and aesthetic display.
