NOTE ȘI DISCUȚII / NOTES AND DISCUSSIONS

THE SAVING OF THE WOODEN CHURCH OF URȘI IN A NEW POSTURE: THE INTER-DISCIPLINARY RESEARCH, PLANNING AND CONSERVATION

Dan Mohanu, Ioana Gomoiu, Ana Chiricuță*

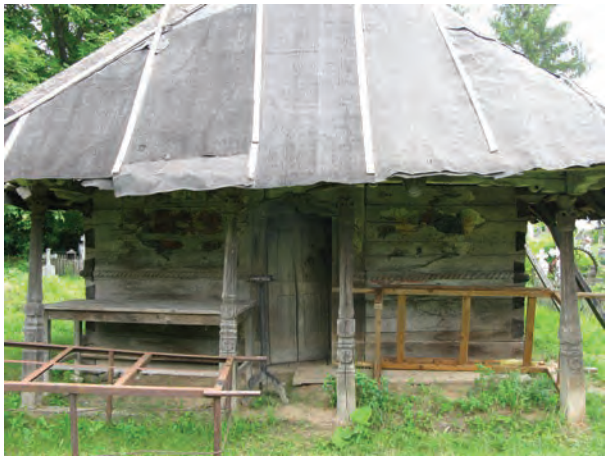
Fig. 4. View toward the porch of the church.

The new iconographic programme was adapted to the space of the wooden church, a specific space for peasant churches, made in our case by the porch supported by thin posts, gracefully sculpted (Fig. 4), the rectangular, small-sized pronaos which is entered through a simple and beautiful portal, the ampler naos and the polygonal altar, provided with a small recess of the proskomidia. A barrel vault made of planks supported by wooden arches covers the naos and pronaos alike. The two rooms are divided by a wall with no tympanum, pierced by a doorway and side openings to North and South, all crowned by ogee arches. The polygonal altar is covered, in its turn, by a vault of planks supported by wooden ribs. The church is part of the group of ecclesiastic buildings with a nave shape and a polygonal altar apse.⁹ The whole construction is made of oak beams assembled into horizontal courses¹⁰ and oak planks for the barrel vault. The construction of the church belongs to an ample tradition of rural wooden

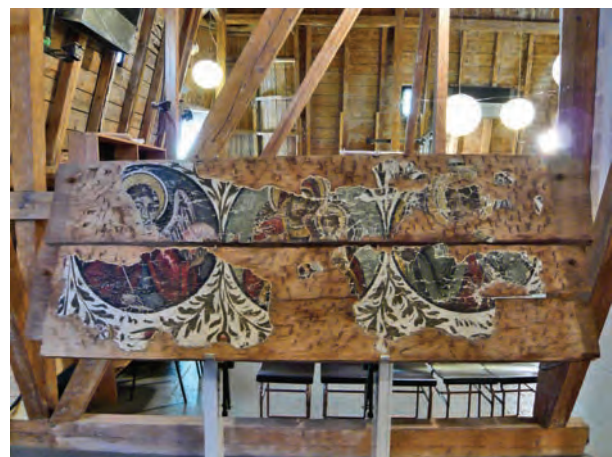
Fig. 6. Two of the planks with mural painting from the collapsed section the altar vault, after the conservation works of 2010. Painting fragments contain a part of the medallions with the images of the Mother of God with Jesus Child and of Holy Archangels Michael and Gabriel.

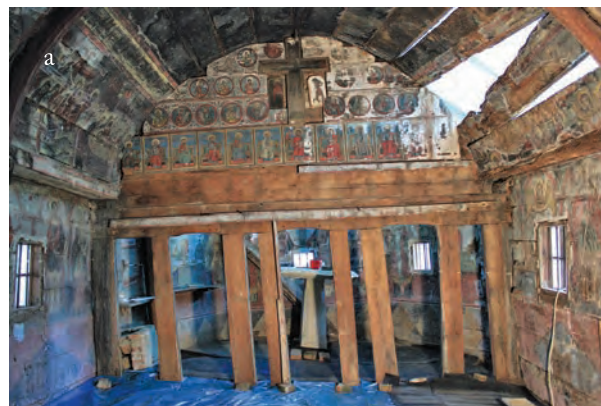
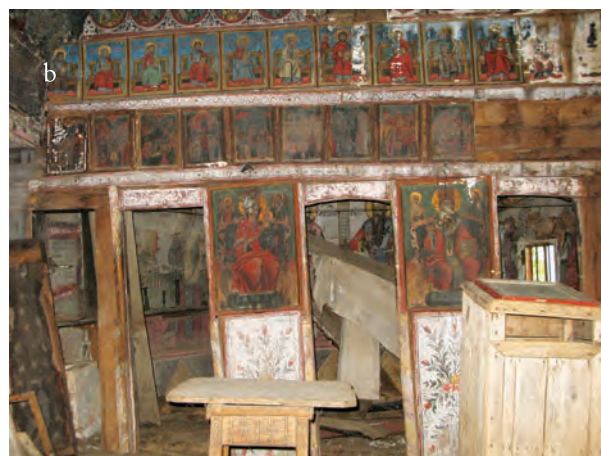
Fig. 19. a. Church iconostasis after the disassembly of the register of sovereign icons and of the festal icons; b. The register of sovereign icons and of festal icons before disassembly and restoration.

The iconostasis of the church in Urși is built in a system mostly used for wooden churches,¹⁸ representing a wall made of posts, a robust transversal beam on which a tympanum made of planks rises up to the cylindrical vault. In the spaces between the posts, the icons and royal doors are fixed, the icon-curtains panels, and on the tympanum, seen ascending, the register of festal icons, the registers of Apostles and Prophets, the *molenie* icons and the cross with the image of Crucifixion (Fig. 19 a, b).

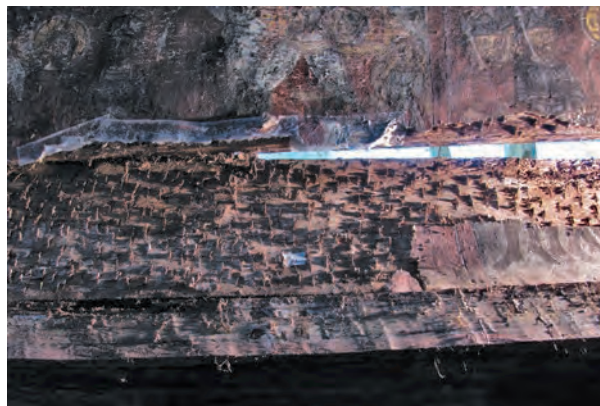
Fig. 20. Adze or hatchet strikes cut into the oak logs to provide a hooking surface for the support-plaster of the *al fresco* painting.

to ensure the adherence of the lime support of the fresco. The team of painters at Urși knew that the only effective solution, on the long term, was of transforming the inner and outer surfaces of the wooden logs and planks in a *hooking* structure, similar to hammering of masonry, resulting from a systematic blowing by adze or hatchet, as if splintering wooden surfaces (Fig. 20). It is a processing similar to preparing laths for lime mortar plastering. The wooden logs thus “hammered” represent at Urși, both inside and outside, the *hooking surface* for the support layer – *intonaco* – of the fresco painting, a

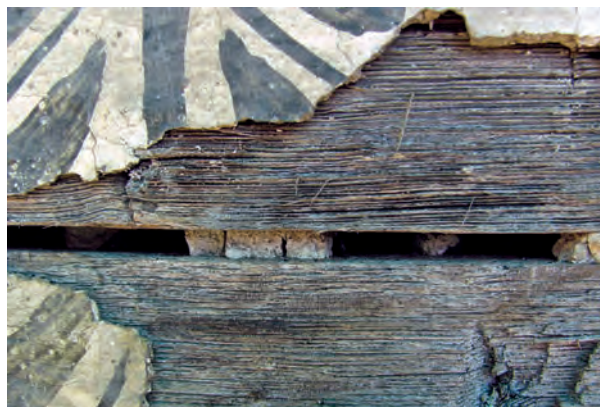
Fig. 21. Spaces between logs were sealed with the same type of mortar used for the support of the *al fresco* painting.

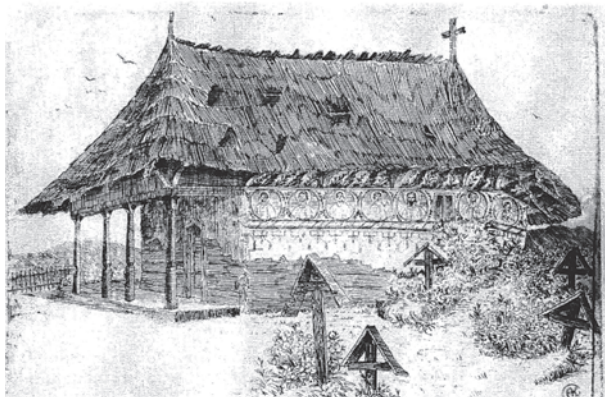
Fig. 23. The image of the Annunciation wooden church of Urși, as viewed by printmaker Anton Kaindl. The work was realised, together with other images representing Romanian monuments, between 1925 and 1939.

church in Urși²⁸ (Fig. 23). Engraving with minuteness and respect for the truth of information worthy of his predecessors, such as Raffet or Bouquet, Kaindl drew the image of the wooden church from the south-western angle. Comparing the state of the church captured by the Swiss engraver with the current state of conservation of the church, we find that the major degradations seen in 2010 were already present in 1927. Besides the ample lacunae of the mural paintings, the engraver remarked the leaning of the construction taking place at the apse of the altar in the northeast. We can also evaluate the state of the roof structure, the degradation of the shingle covering, the gaps in the roof and the general state of abandon the exterior image of the church conveyed as early as the first half of the 20th century.

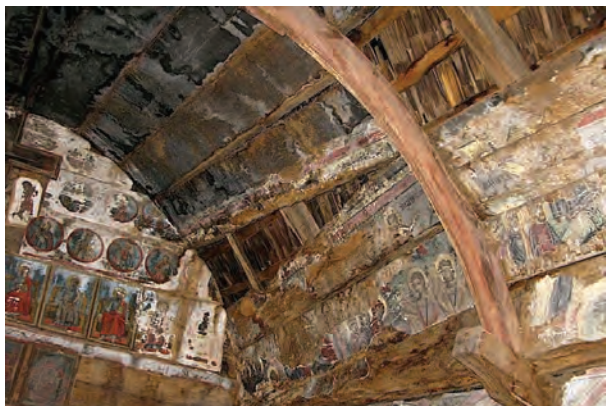
Fig. 24. The south-eastern area of the naos vault with complex degradations of the wood, fresco painting and *al secco* painting of iconostasis.

Infiltration humidity represents the effect of degradation, through the lack of a permanent monitoring and a systematic maintenance of the protection system: the roof structure, the system to collect and channel pluvial waters, gullies and drains, the setup of the perimetral terrain. In our case, the roof of the church suffered degradations which the anamnesis pointed out as being part of a long period of lack of maintenance or even abandon of the church. The infiltrations of rainwater resulted in successive deformations of wooden logs and planks, and of icon panels as well. Along with deterioration of wood, the infiltration humidity produced serious degradations to the ground and the pictorial layer of icons, as well as to the mural paintings. The waters coming inside the church through the deterioration of the roof represented at the same time one of the sources of humidity with a vital role in the emergence and development of biodeteriogenes, generating serious deterioration forms, hard to be treated, on the wooden material which makes both the structure of the church and the support of the mural paintings and icons (Fig. 24).

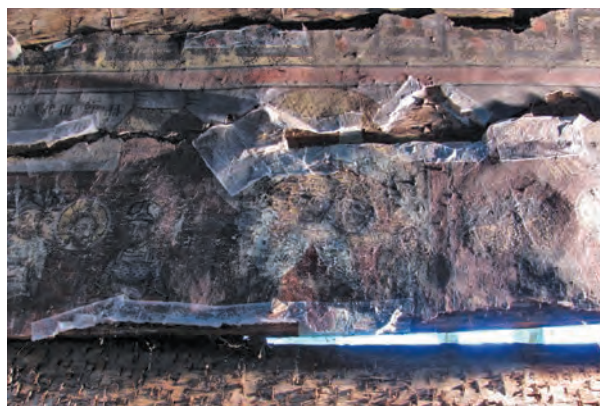
Fig. 25. Raking light highlights both the dislocations of the vault planks and the detachments and the lacunae of the fresco painting.

Seismic movements are also part of the category of natural factors with disastrous effects even in the case of relatively light and highly flexible constructions. Besides structural dislocations, the movements of logs and planks which bear fresco painting caused cracks and lacunae along the joints (Fig. 25).

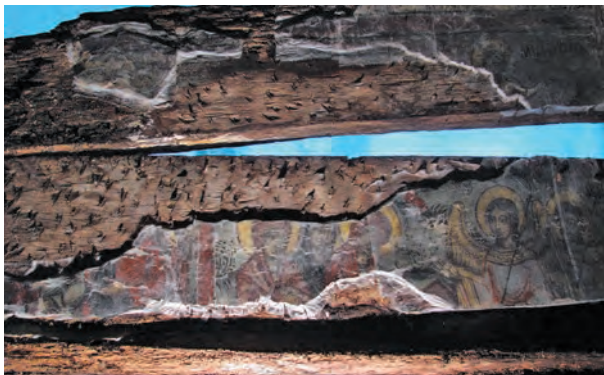
Fig. 27. Degradation of wood exposed for a long time to infiltration humidity, and displacements of vault planks resulted in wide losses of the fresco painting.

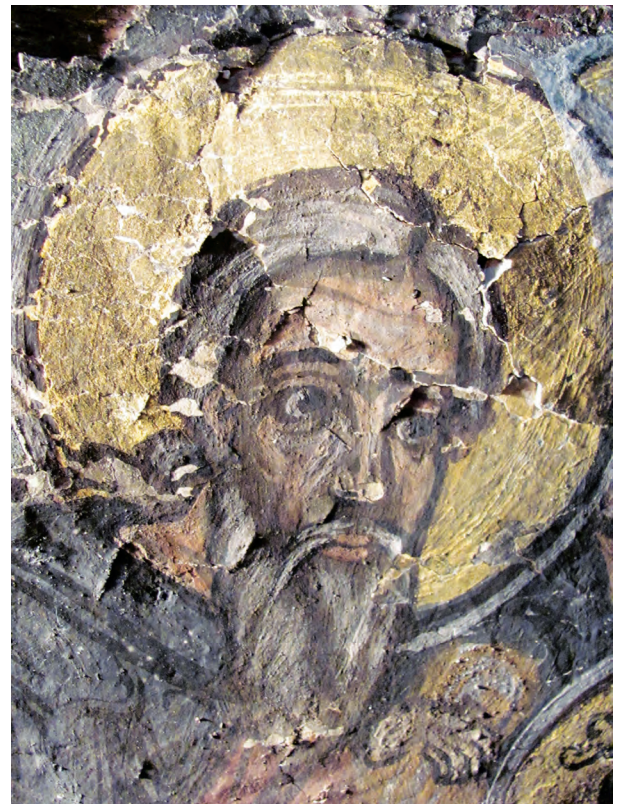
- exfoliations with various morphologies along the contraction cracks and of those resulted from the movements and the dislocations of the wooden material (Fig. 28, 29);
- powdering of the pictorial layer on certain tones, where the carbonation was insufficient or there were *al secco* interventions;

Fig. 28. Movement of wood with fresco painting caused detachments, fractures and distortions of the lime support reinforced with hemp.

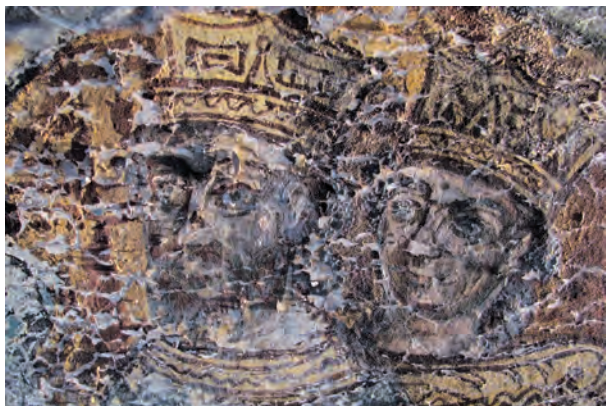
Fig. 29. Possible technical faults, but mostly infiltrations of rain water and microclimate conditions generated the emergence of exfoliations with various morphologies of the pictorial layer.

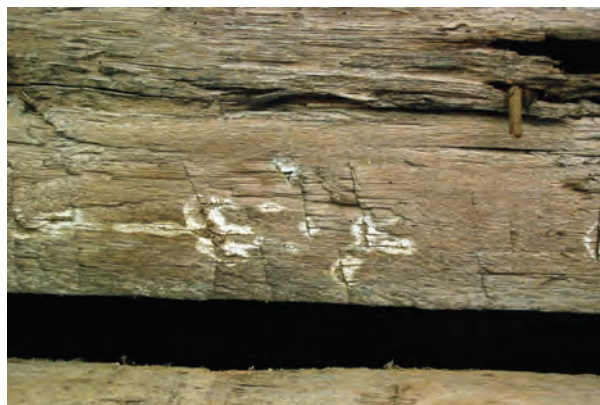
Fig. 31. Basidiomycetes mycelium and flight holes (photo V. Albu).

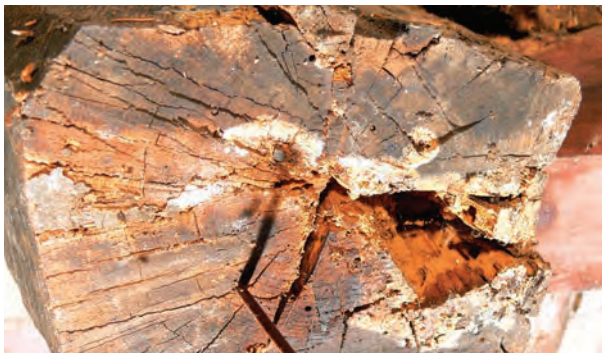
Fig. 33. Extended mycelium of basidiomycetes and flight holes.

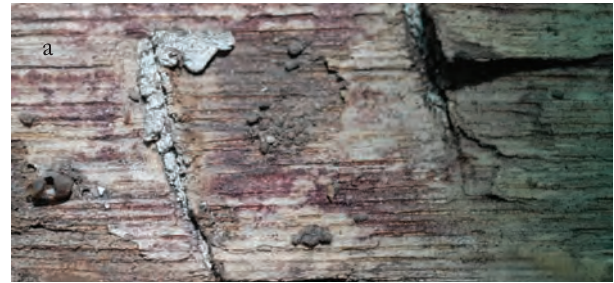
In the pronaos, areas where the wood was coloured purple here remarked, given the development of the mycelium of *Fusarium sp.*, but also black-coloured colonies belonging to the species of *Aureobasidium pullulans* (Figs. 34 a, b). The aesthetic aspect of the wood is affected, as well as the structural one (fungi synthesize cellulase and lignolytic enzymes).

Fig. 34. a. Wood colonized by *Fusarium sp.*; b. Wood colonized with *Aureobasidium pullulans* (photo I. Gomoiu).

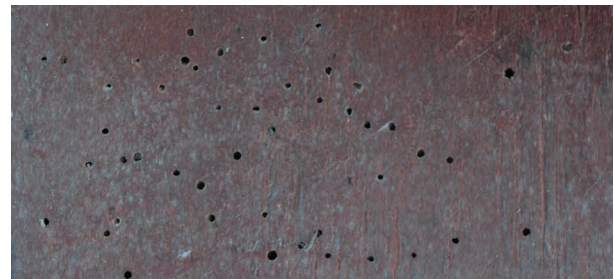
Fig. 35. Flight holes on the wood of the iconostasis.

On the wood of the iconostasis (Fig. 35) and the naos (Fig. 36) the flight holes of the xylophagous insects are visible. Only the larvae are active, during the biological cycle of the insects, both in terms of

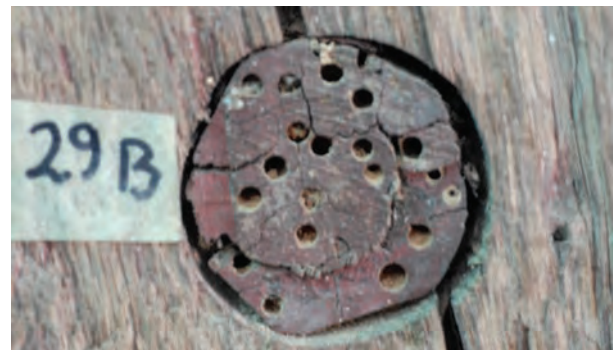
Fig. 36. Flight holes on the wood in the naos.

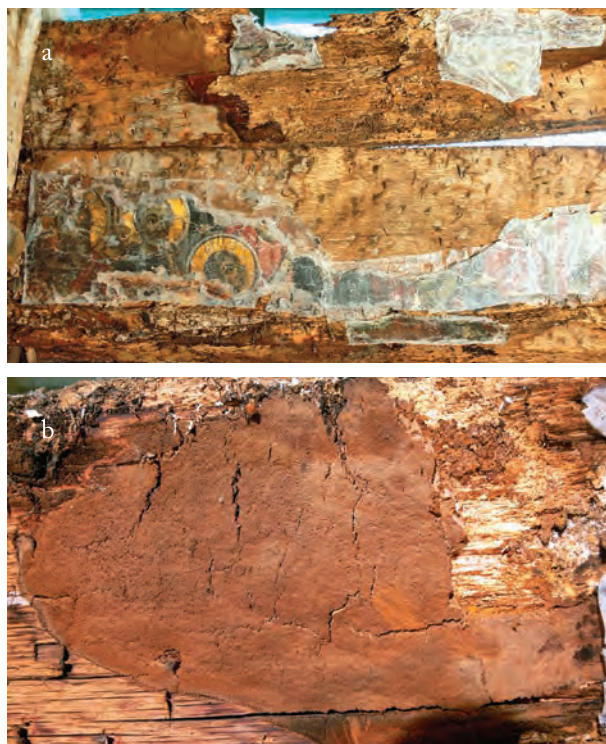
Fig. 37 a, b. Fructification bodies and mycelium of *Antrodia sinuosa* (photo V. Albu).
